DAMAGE ASSESSMENT REPORT

Conflict Period and following Demolition of the Old city (SURİÇİ) of DIYARBAKIR

August 1, 2017

“DIYARBAKIR FORTRESS AND HEVSEL GARDENS CULTURAL LANDSCAPE”

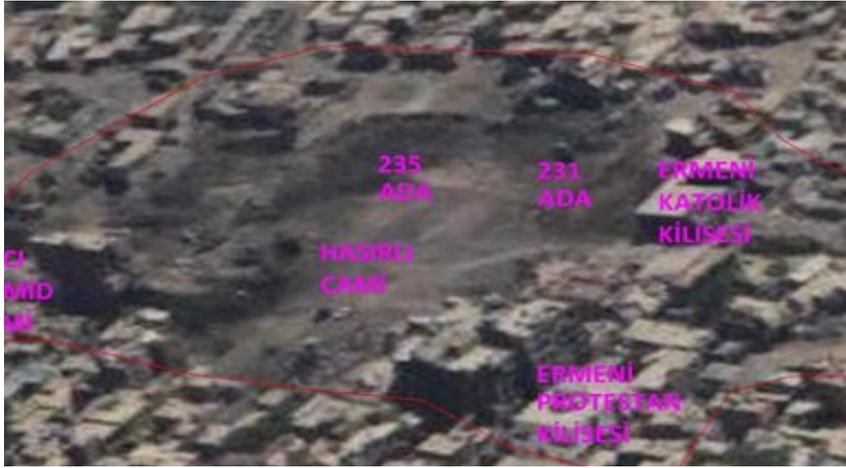
Photo 2: Aerial photographs underline that the Hasırlı Mosque, located at parcel no. 235/19 has been completely destroyed and the debris removed, without a trace left in its place.

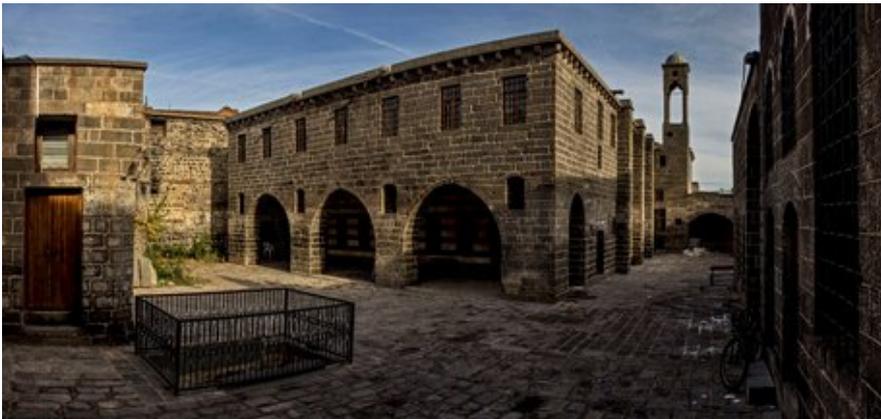
The bell tower, south courtyard wall and pool in the courtyard have been destroyed completely and the main entrance door and church outbuilding located to the west of the church have been destroyed partly. Also a wide road through the area has been opened.

Photo 3: After the restoration in 2014

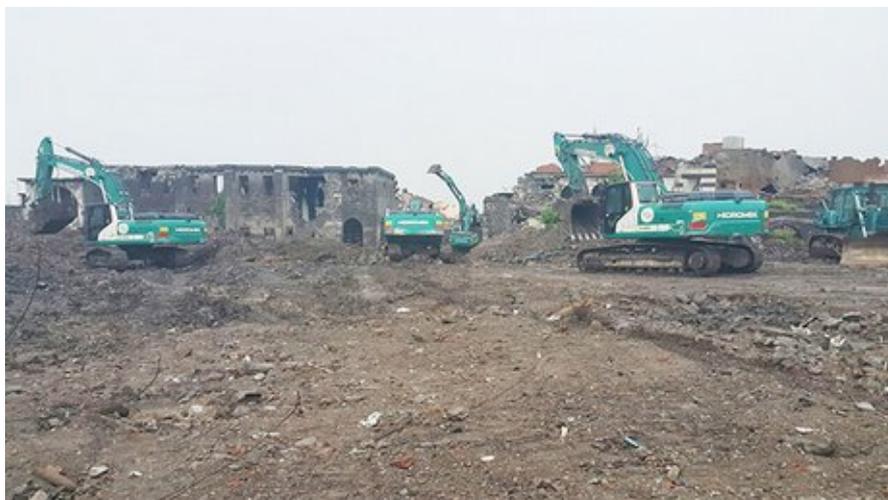
Photo 4: The destruction resulting from razing a road through the church; March 2016

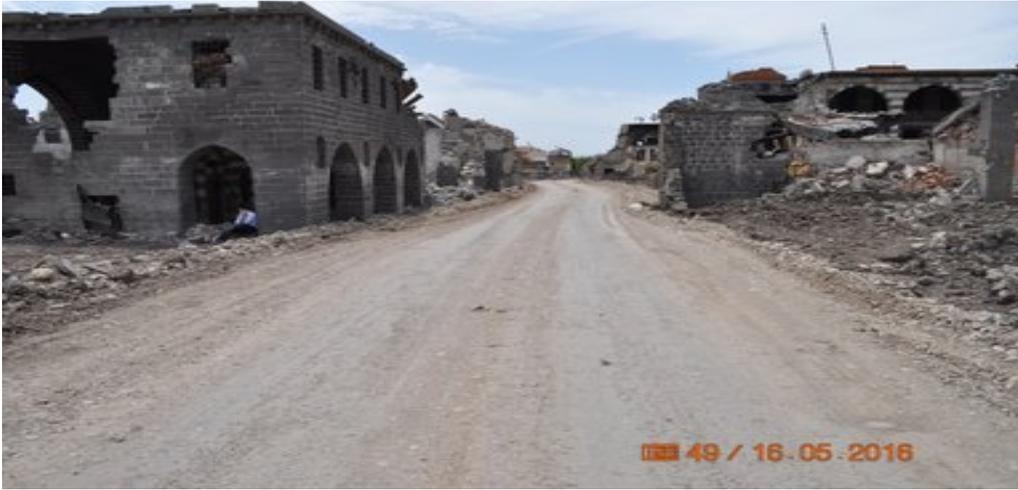
Photo 5: the opened road through the area of the Armenian Catholic Church; May 16, 2016

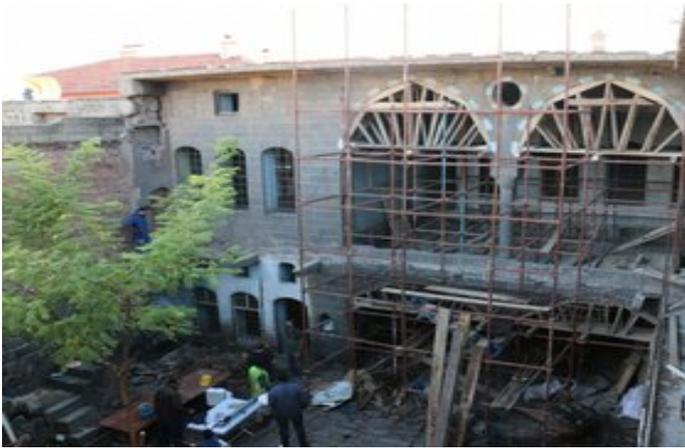
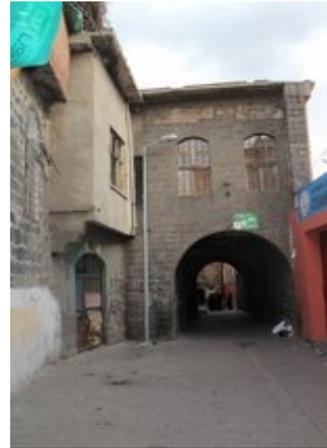
The registered civil architecture, projected to become the Mehmet Uzun Museum. Restoration process begun before the conflict but could not be completed. The roof has been destroyed and the carrying system has been damaged.

Photo 6: Restoration works before the demolition, 2015

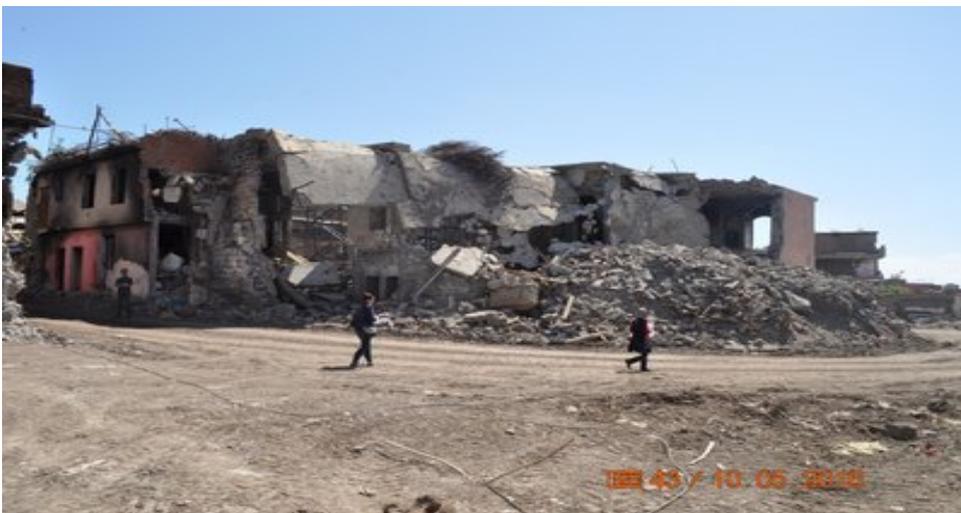
Photo 7: Mehmet Uzun House, after demolition; May 10, 2016

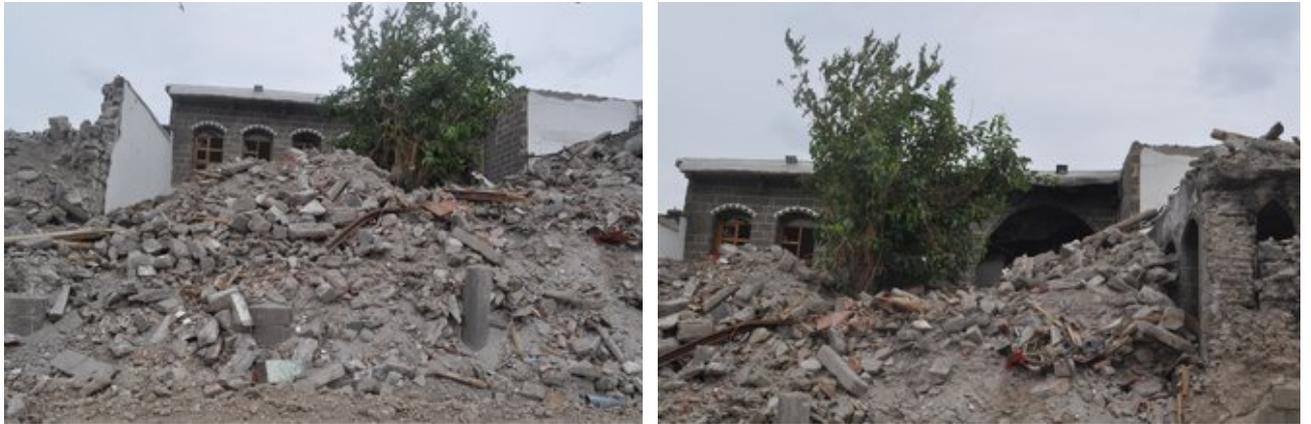
The southern part of the building of the Chamber of Trade and Industry has been demolished in order to widen the Yenikapi Street, which connects the center with the eastern gate Dicle.

Photo 8: View at the registered building belonging to the Chamber of Trade and Industry; May 2016

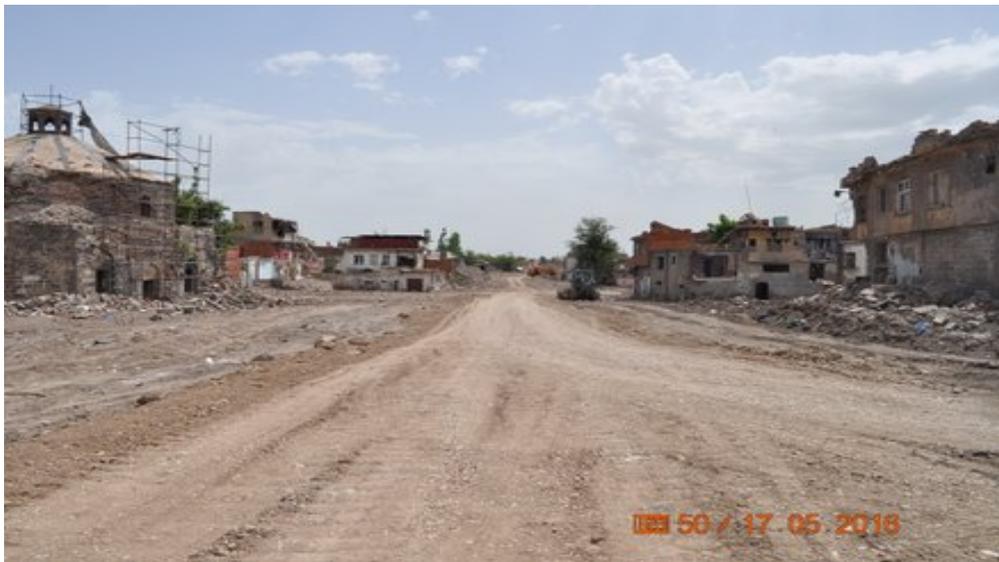
Photo 9: The Yenikapi street, with an original width of 8m before the demolition, has been turned into a 15 m wide street.

However, in the course of the demolitions continuing non-stop since March 2016, the Urban Conservation Plan has been revised by the Ministry of Environment and Urbanization in December 2016, without to consult the Diyarbakir Metropolitan or local Municipalities. This act follows based on high security priority the long expressed purpose to implement gentrification and commercialization in the historical site Suriçi. This new security minded urban conservation plan intends, in effect, to create legitimacy and legality for the demolitions in Suriçi which destroyed the authenticity and cultural fabric. The official reason for the revision has been stated as security. In this sense, schools have been turned into military/police stations, but no alternative educational areas have been determined. Areas around military/police stations and streets connecting these stations have been widened so much allowing the passage of military vehicles, including tanks. The Yenikapı street with a width of 7-8 m and high intensity of registered monuments, has been widened to 15 m.

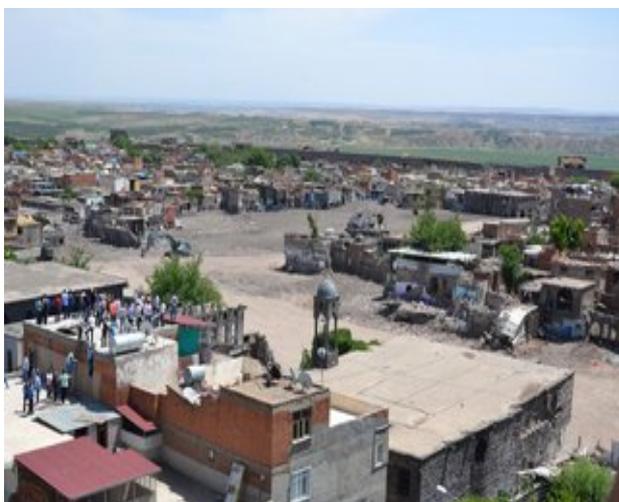
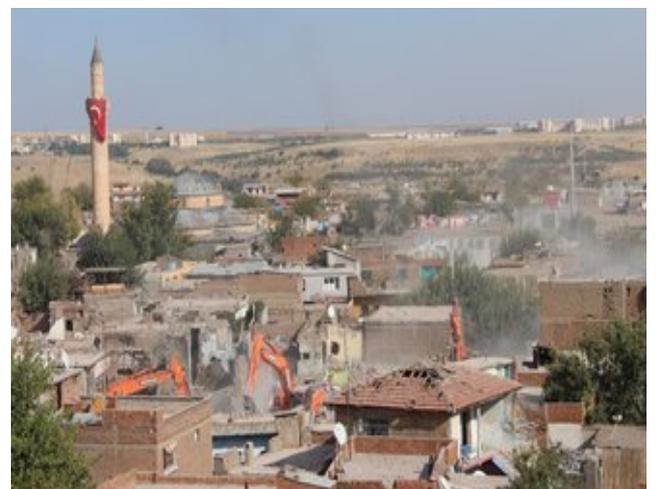
Photo 10: Excavators in the Yeni Kapı Street **Photo 11:** Destruction behind Kurşunlu Mosque, May 2016

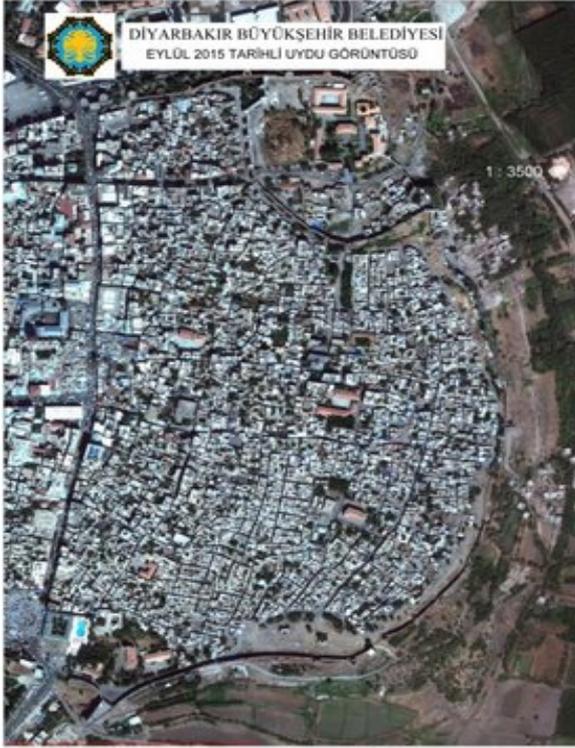
Photo 12: Satellite image, before conflict; 2015

Photo 13: view from commercial flight; April 2016

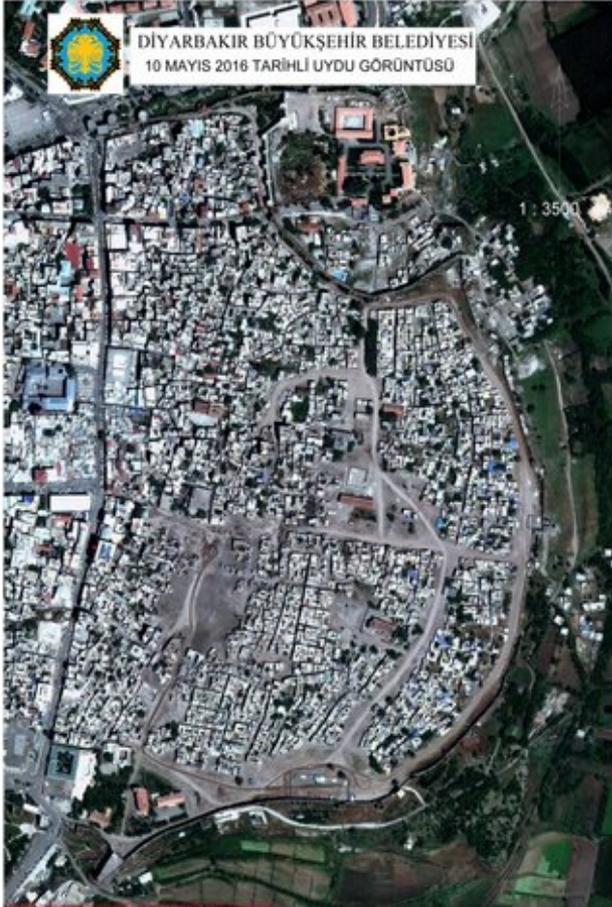
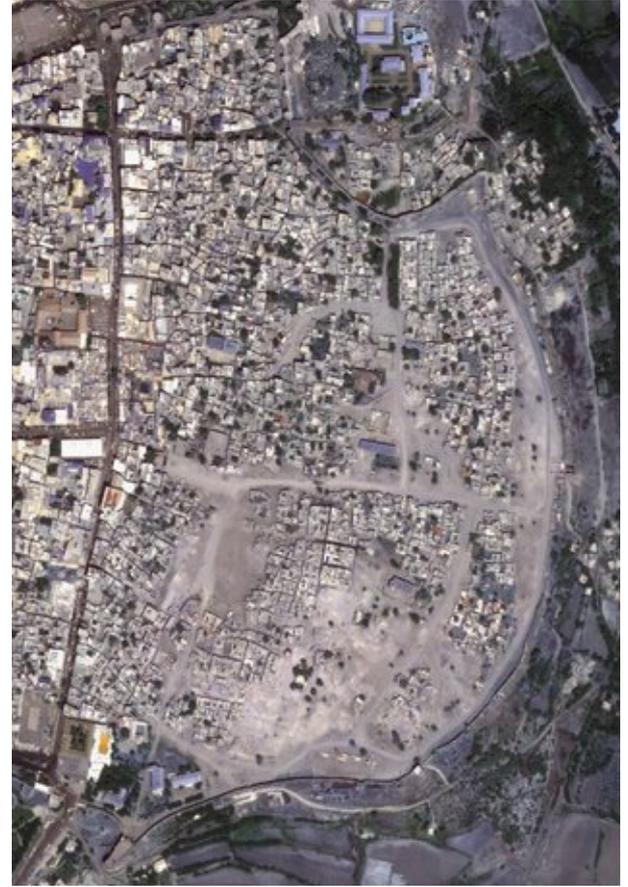
Photo 14: Satelliite image May 10 2016,

Photo 17: Satellite image, August 16, 2016.

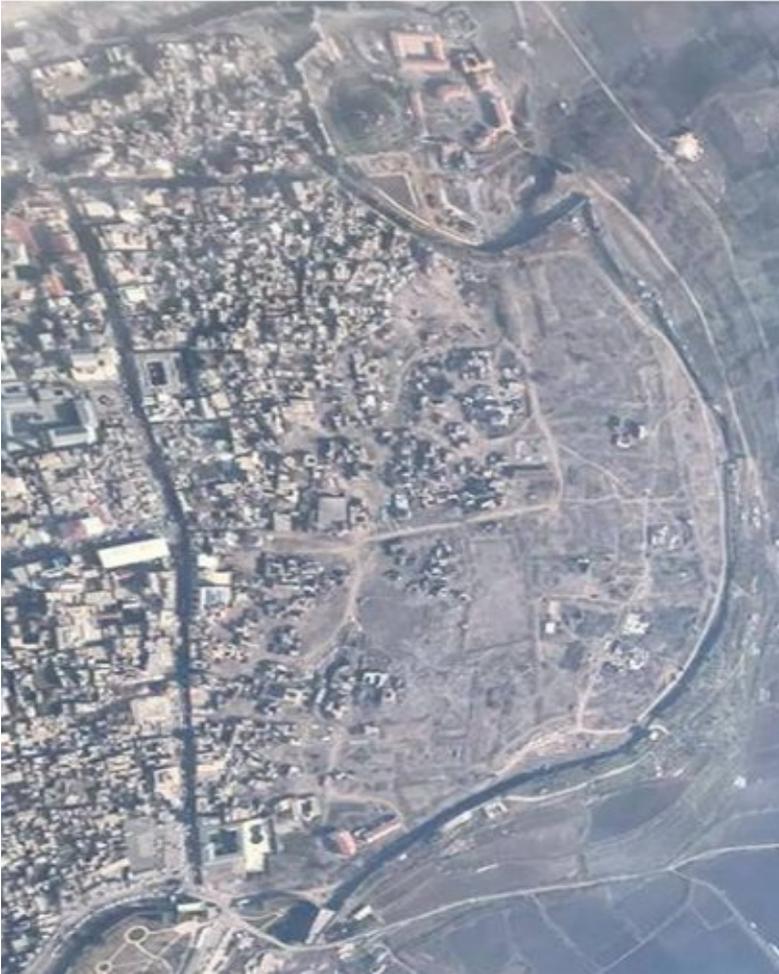
As a result of the demolition, which is going on since February 2016 as of the writing of this report (August 1, 2016), Suriçi, buffer zone of the World Heritage Site and a Registered Urban Site has been turned into a bare flatland. (See Photos 18 and 19). It has been assessed that until at least July 2016 registered buildings have been destroyed completely. Many monuments listed into the Urban Conservation Plan of 2012, because of their addition to the urban fabric as constructions with environmental value, have been destroyed completely.

Photo 18: Picture taken from a commercial flight; April 4, 2017

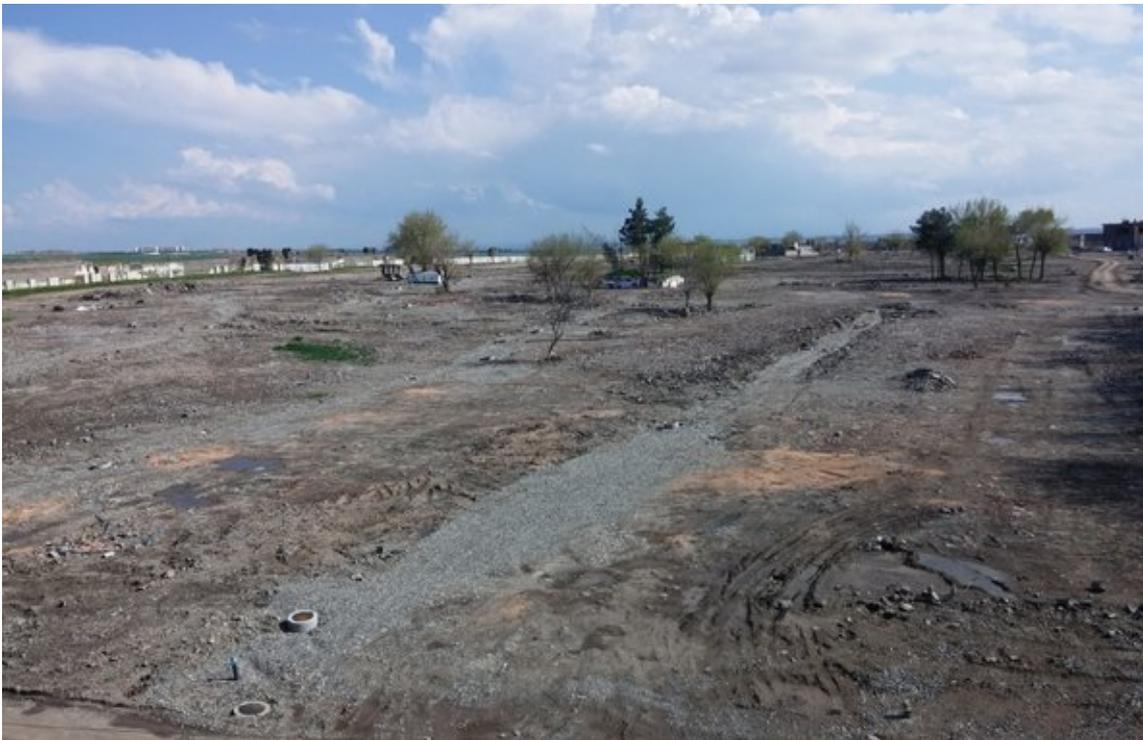
Photo 19: Inside the walled old city, erased and turned into a flatland; April 19, 2017

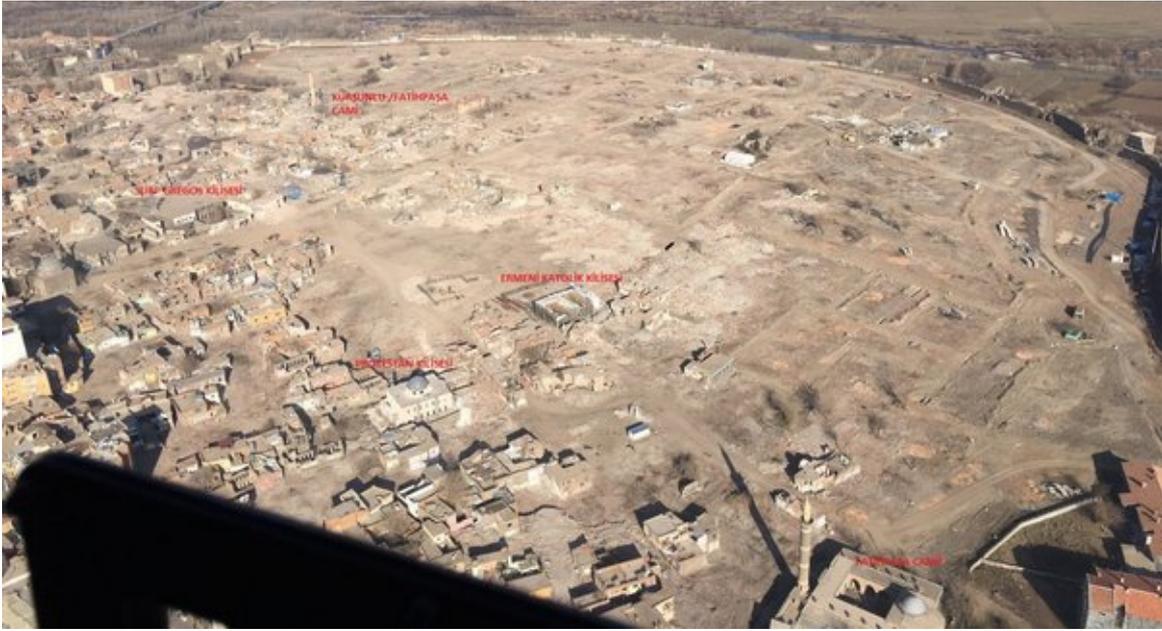
Photo 20: Picture taken from a commercial flight; May 4, 2017

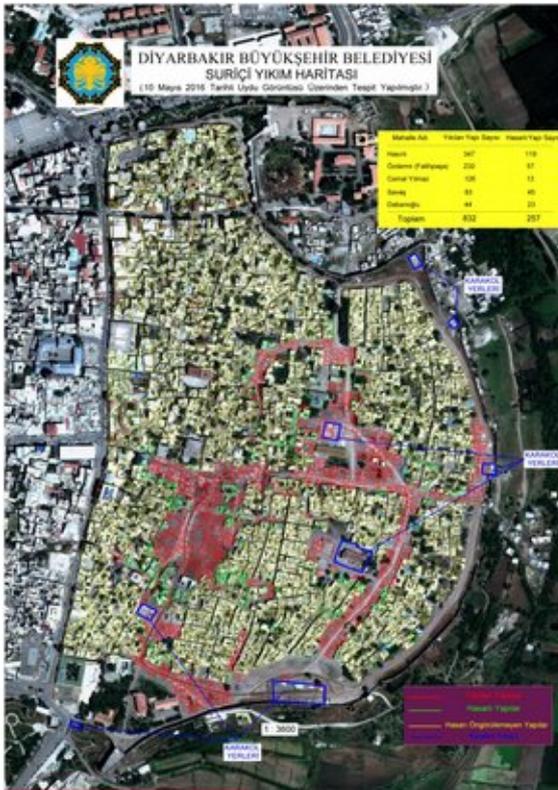
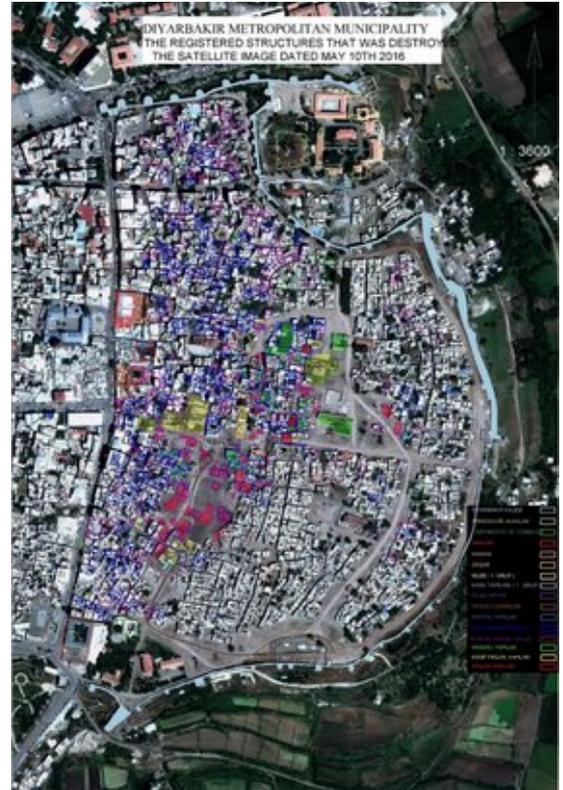
Total number of parcels of land in Sur is 7714. In the 6 blockaded neighbourhoods this number amounts to 3646. The parcels belonging to the demolished buildings were documented by superposition the cadastral maps with the satellite images. Satellite images from May 10, 2016 show that 10 hectares have been demolished, whereas in August 16, 2016 the destruction covers 20 hectares. After the seizing of the Diyarbakir Metropolitan Municipality and Sur Municipality and appointing of an forced administrator, satellite images are not available but pictures were taken from commercial flights during landing or take off. (Photos 13 - 20).

Maps 2 and 3: Satellite picture. (left) Suriçi with marked destroyed area, and (right) marked locations of demolished registered or demolished environmentally significant buildings; May 10, 2016

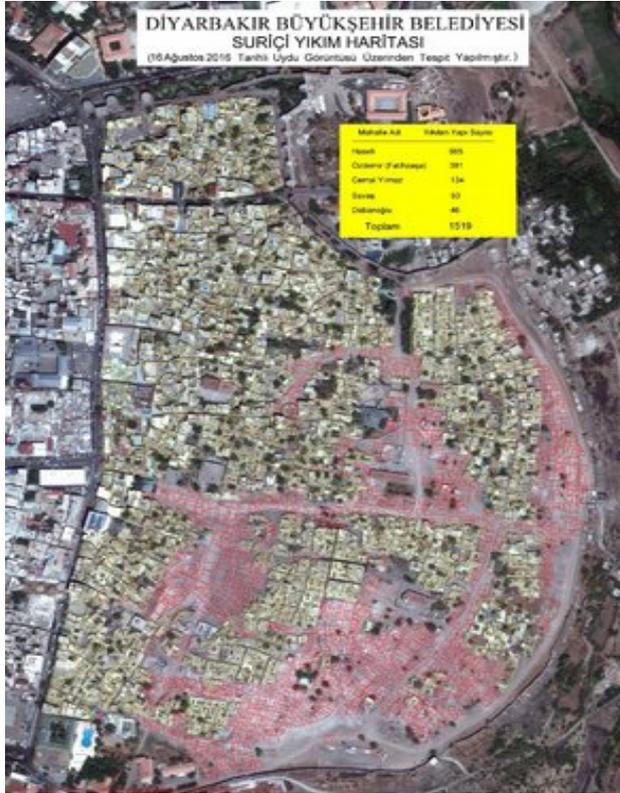
From the satellite image of August 16, 2016 it has been assessed that a total of 1519 buildings and other constructions have been destroyed completely, among them registered civil and monumental buildings. 89 registered monuments have been destroyed completely and 40 partially. 41 monuments have only been damaged. Of these registered structures 76 are of civil, 13 of monumental and 81 marked as environmentally significant buildings. These numbers are growing every day.

Map 4: Satellite image illustrating demolition in the old city. August 16, 2016

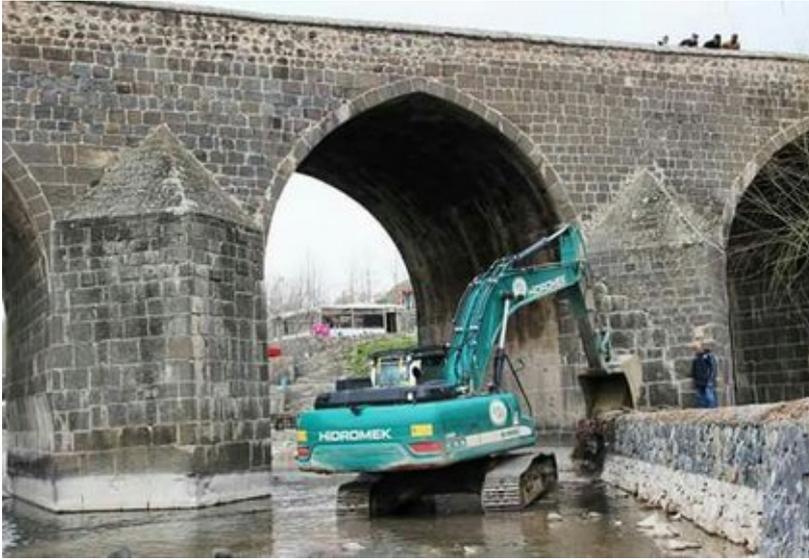
But, in the aftermath of the demolitions and the expropriation of the land, both the urban renewal project and the Tigris Valley Project were once more put into effect. The first stage of the Tigris Valley Project has started at and right next to the historical Ten Arches Bridge, which is part of the World Heritage area. The Project includes the building of a mosque, a car park and restaurants in the buffer zone adjacent to World Heritage area.

Photo 23: Work being conducted at the Ten Arches Bridge, part of the Diyarbakir World Heritage Cultural Landscape; March 26, 2017

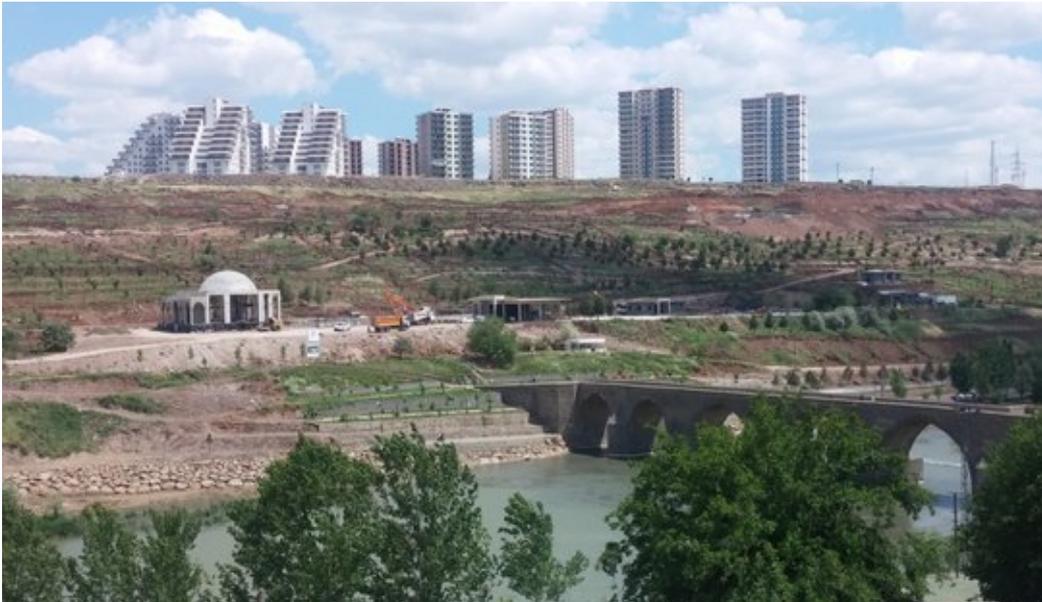
Photo 24: Tigris Valley Project first stage; May 22, 2017

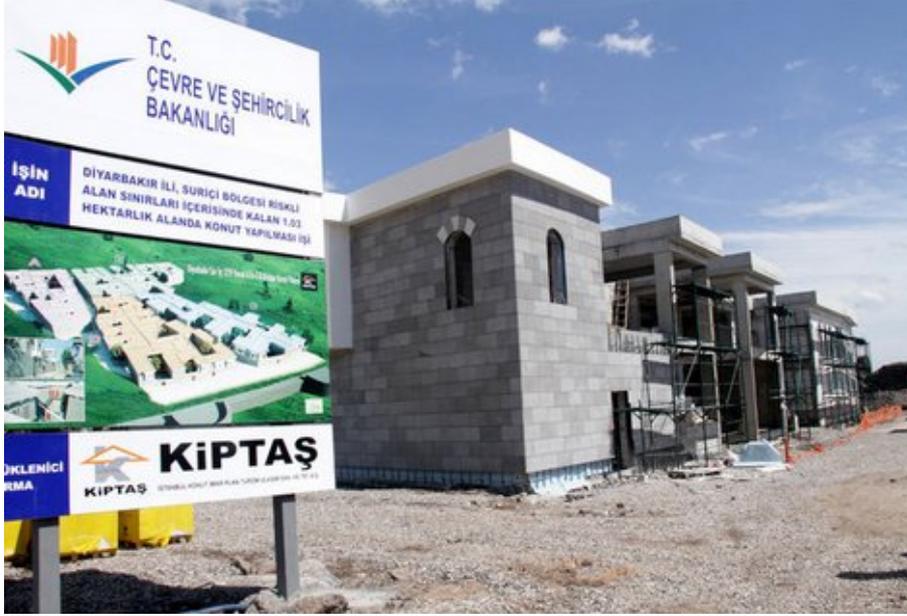
Reinforced concrete housing, which in complete violation with the historical old city fabric and the traditional Diyarbakir houses, is being built in areas which have been erased. These houses clearly violate norms of the Urban Conservation Plan; the mass volume of the buildings, the dimensions of the courtyards and walls do not fit with the street and parcel sizes. Instead of basalt blocks, which is the traditional building material in the city, thin slabs of basalt are being used to cover the concrete walls. The exterior appearance of the buildings has nothing to do with the traditional street view of Diyarbakir. Moreover, the forced eviction of the inhabitants, the demolition of thousands of houses and the expropriation clearly indicate that the true owners of Sur will never be allowed to return to their homes again. But who, then, will be living in these new houses? It is obvious that the aim is to transform the political and demographic structure.

Photo 25: New houses being built in the old city Suriçi

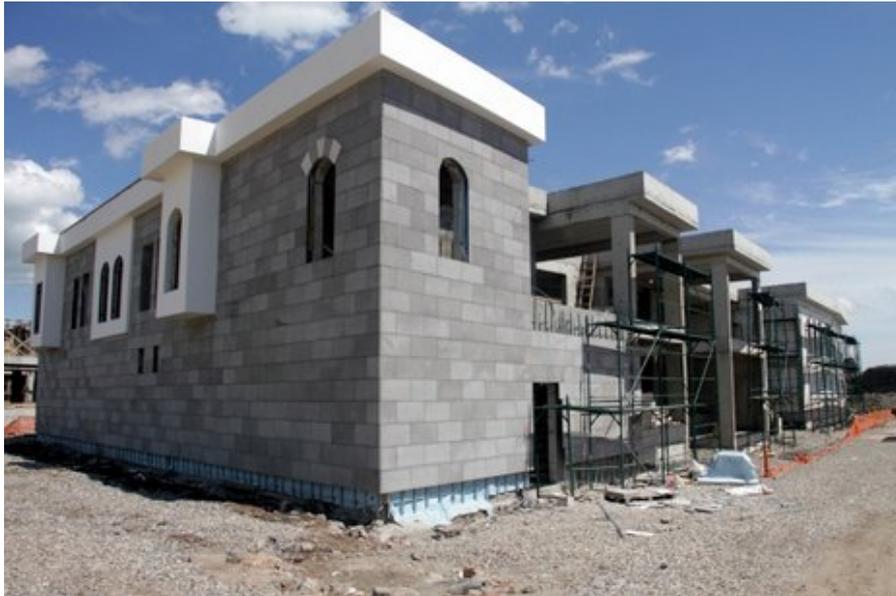
Photo 26: In spite of the stipulation by the conservation Plan, that concrete houses with a deceptive thin stone facing are not to be allowed, the picture shows new reinforced concrete houses coated with basaltic slabs.

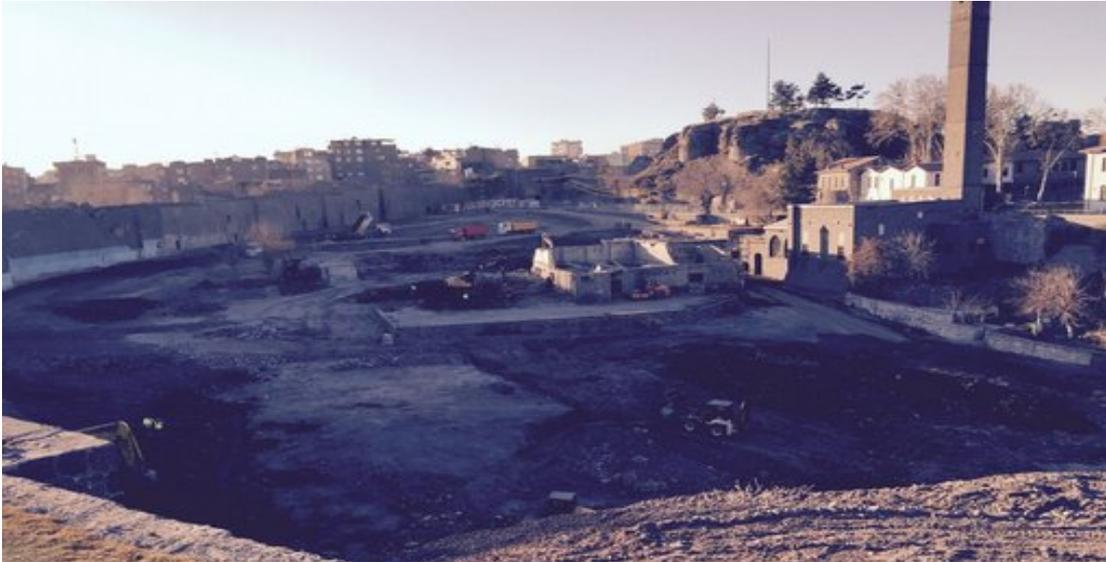
well as was highlighted in the Site Management Plan. What we observe nowadays is that in the area of the second stage of the project all buildings of low quality have been removed and a registered building has been de-registered and then immediately demolished. The cleared space has been designed as a modern park. Meanwhile with heavy equipment excavations have been conducted and many trees with extensive roots have been planted. All of these interventions have the high probability of damaging the archaeological structures under the earth.

Photo 27: View at the registered building next to the Ickale Mosque, Inner Castle. After deregistration it has been demolished

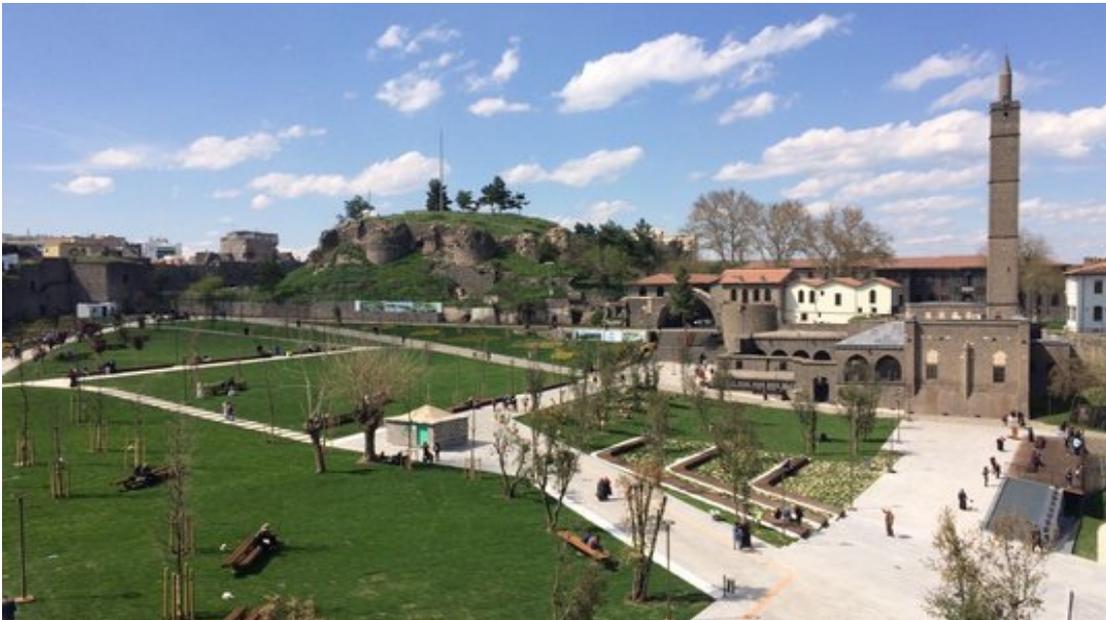
Photo 28: The modern park in the Inner Fortress. The registered building next to the mosque (see Photo 27) has been removed completely.
